### **ARCHER**

## **Report of complementary environmental test results**

ARCHER - Contract Number: 269892  
Advanced High-Temperature Reactors for Cogeneration of Heat and Electricity R&D  
EC Scientific Officer: Dr. Panagiotis Manolatos

| Document number | D42.22 |

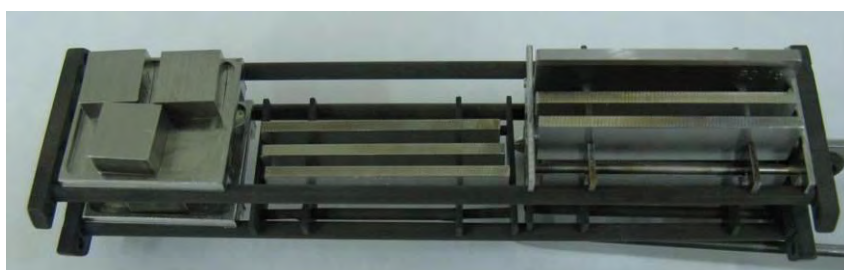
Figure 6: Samples of alloy 800 H in the holder before exposure in HTF

During this test the humidity of the gases was controlled before entering the oven, the optical hygrometer and molecular sieve are installed. A picture of the holder can be seen in Figure 6.

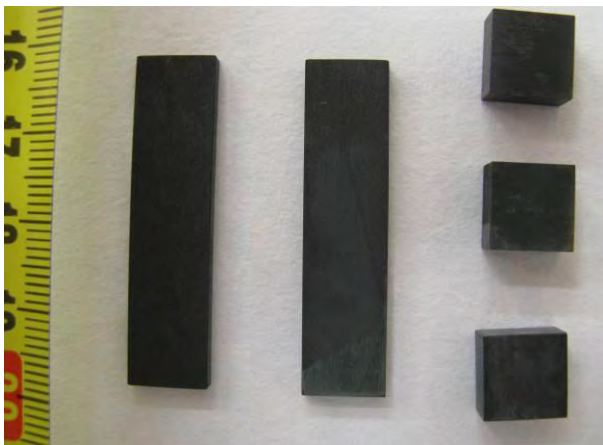
a)

Figure 30 shows the samples in original state, picture of samples after exposure shows Figure 31. On the surface of the samples a black-greenish corrosion layer is visible. For samples with weld metal (WM), with heat affected zone (HAZ), and basic metal (BM) the corrosive layer showed a different nature within these specified regions, see Figure 32. The mass changes depending on time of exposure are presented in Figure 33. The mass change for alloy 800H is greater than for steel P91 after exposure at 760°C for 1500h at an atmosphere as described in Table 9. Further information will be provided in the next section.

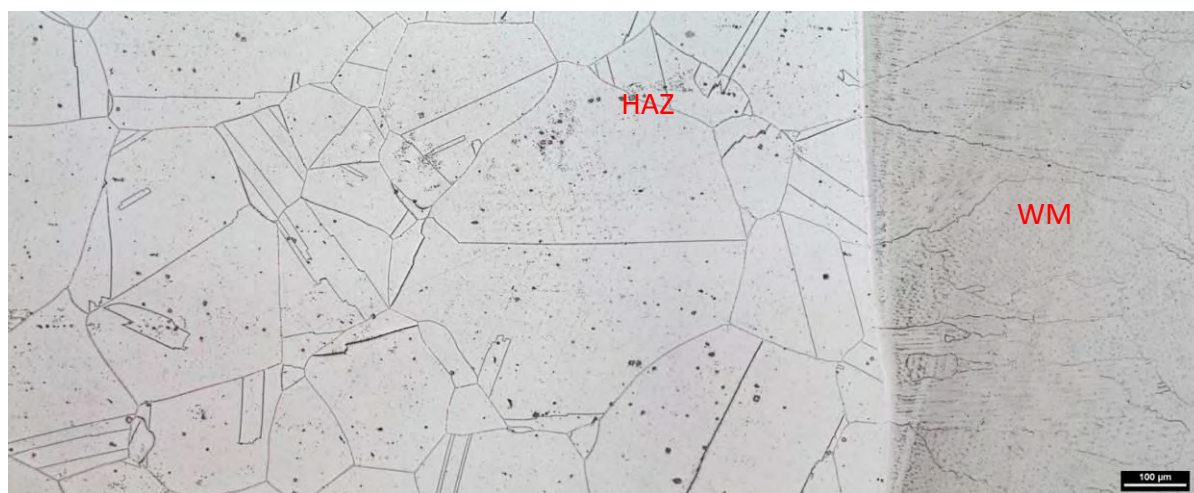
**Figure 55: Microstructure of the cross section of the HAZ-WM boundary of the specimen 5S exposed in HTHL during test operation during 665 hours**

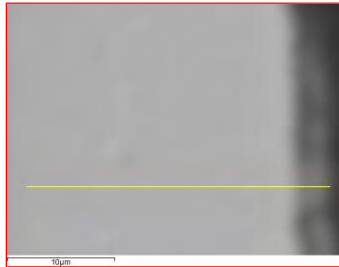
SEM/EDX linescan of cross-cut of specimen L01 (steel 316, machined surface, exposure 750°C/1000 hours in He (composition listed in Table 5))
