### **ARCHER**

## **Destructive PIE reports on EU1 irradiated fuel elements**

Advanced High-Temperature Reactors for Cogeneration of Heat and Electricity R&amp;D

| Document number | D32.12 |

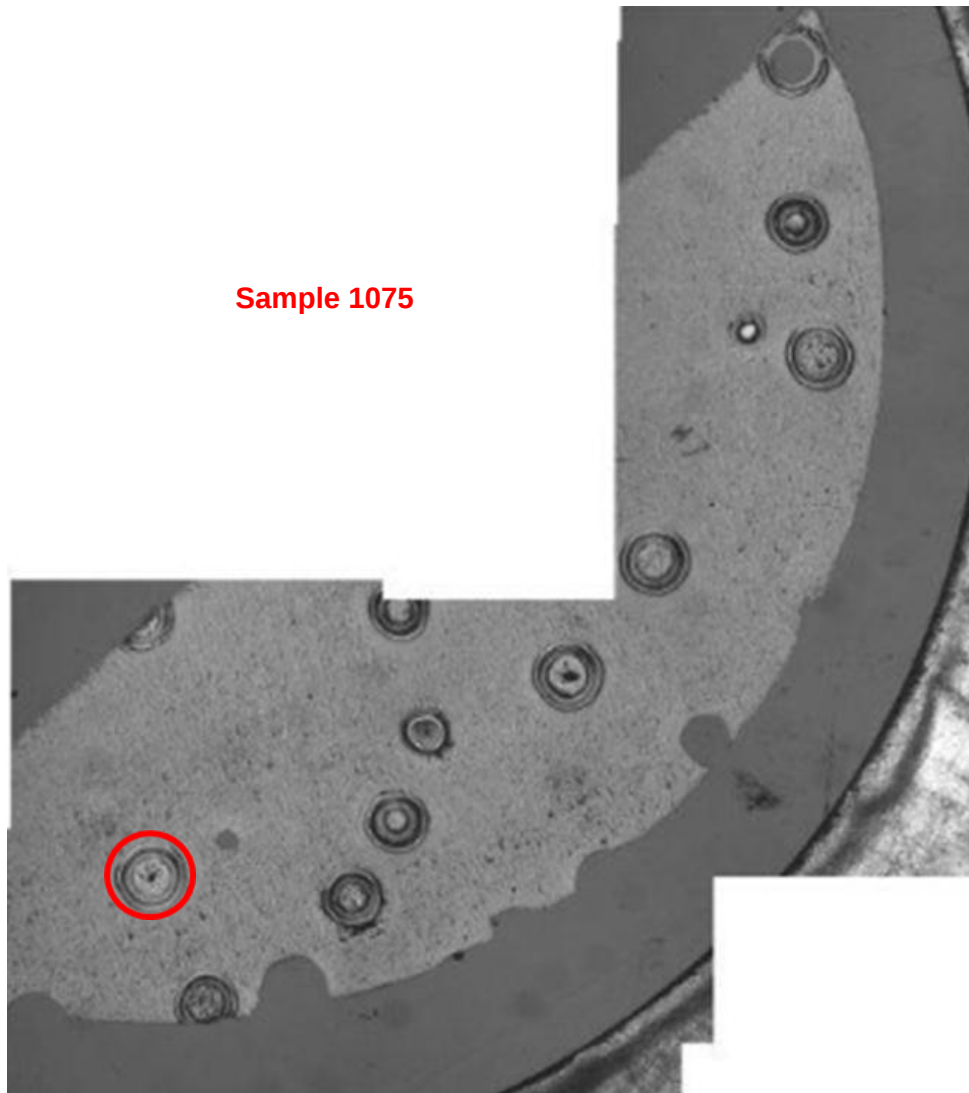
Figure 15: View of the cross-sectional plane of the sample 1075

Sample 1075 was selected for subsequent examination with the SIMS. Considering the quite tight planning before the closure of the ARCHER project only the analysis of the coted particle inside the red circle will be taken into account.
