**HTR-E**

**High-Temperature Reactor Components and Systems**

**Deliverable D41-a for "Tribology in Helium Environment"**

| <b>Titre</b> | <b>HTRE – Deliverable 41 of WP5</b> (ref : 05/12-D-5-3-1-1/2-b)<br><b>Results of elementary tests</b> |

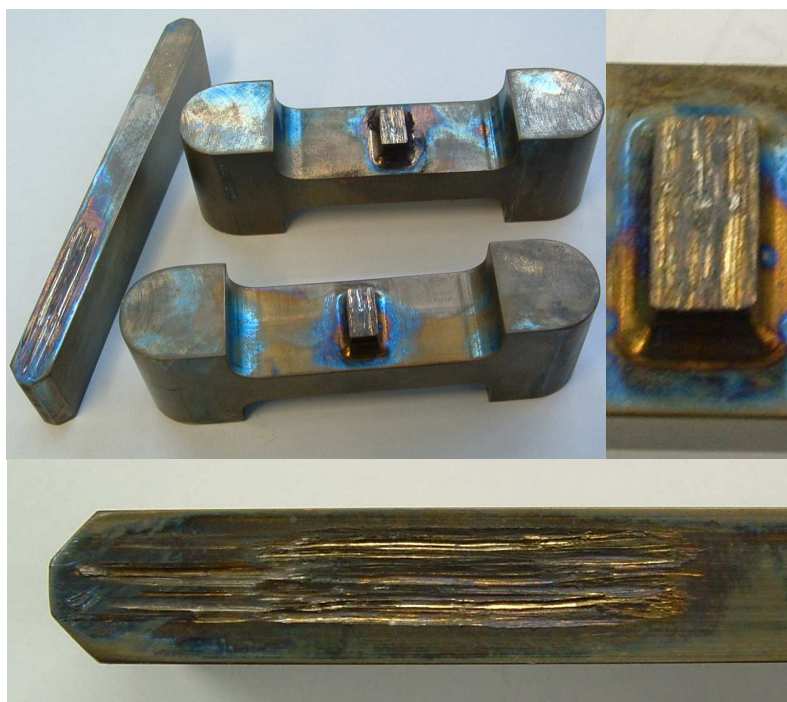
After 2600 cycles, and the removal of the samples, a macroscopic observation of the contact (figure 2) show a wear essentially due to adhesion with a little part of abrasion occurred by wear debris (work hardened) harder than the massive materials.

**figure 2 : Friction surface of HR230 after 2600 cycles at 450°C under 5 MPa of contact pressure**

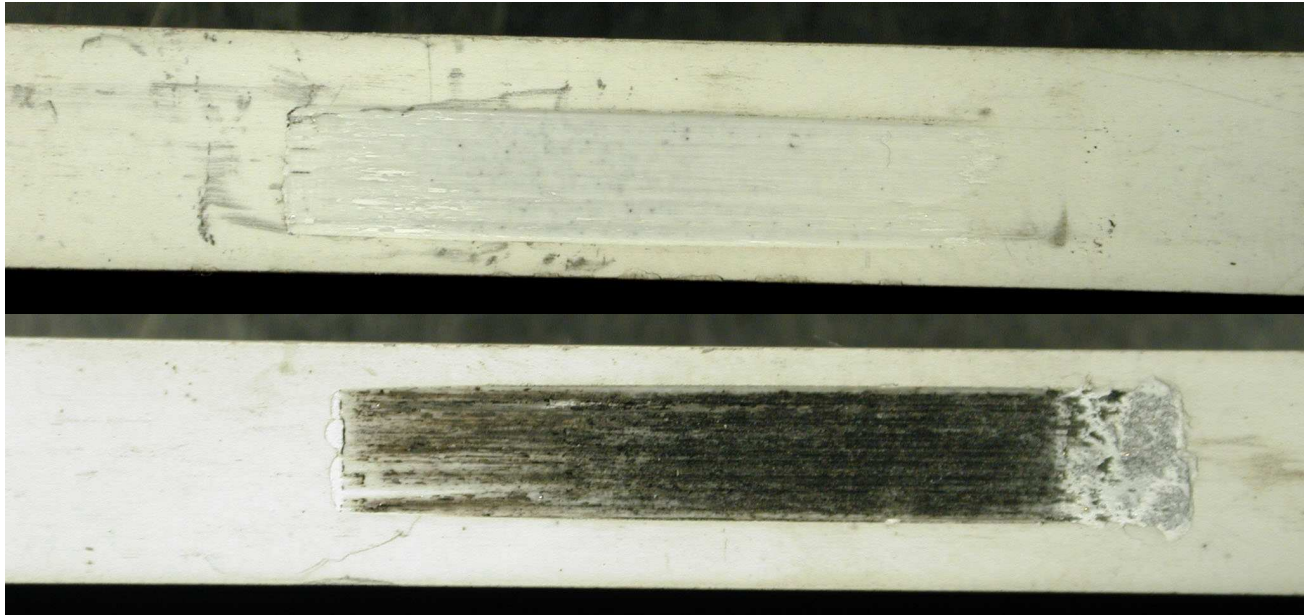
After 1500 cycles and the removal of the samples, an observation of the friction surfaces shows a too high wear of the coating, fetches up to crack of one of the surfaces of the rail (figure 5). The main accommodation way is “abrasion”, with the formation of debris like a powder.

**figure 5 : Friction surfaces of the rail coated by Zirconium after 1500 cycles under 800°C and 5 MPa of contact pressure.**

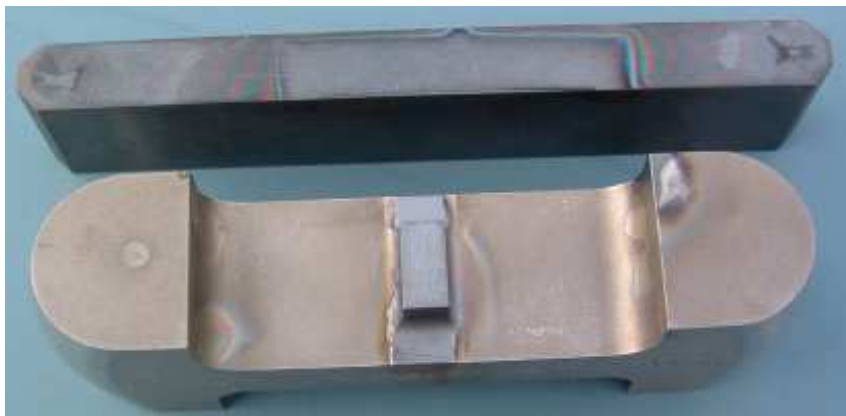
**Figure 14 : SiC after PVD coating**

After SiC PVD coating, samples present refringence rays on the coated surfaces, showing a gradual structure difference of the coating.

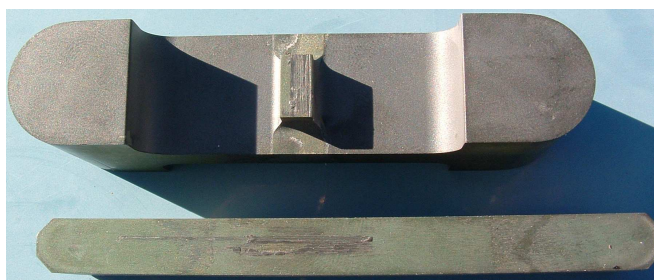
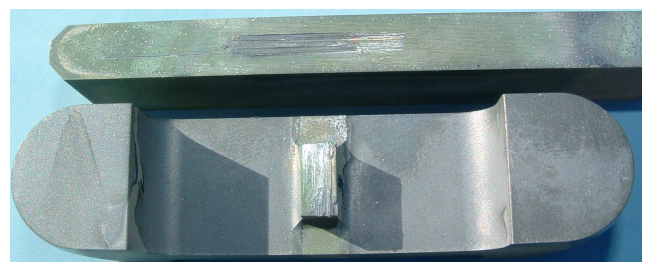
After removal the samples, the observation of the surfaces of friction shown the disparition of the coating on the wear track (figure 15). The coating was too thin and too brittle to run under such conditions : 5 MPa and 900 °C.

**Figure 15 : Sample of SiC after 1000 cycles under 900 °C and 5MPa of contact pressure.**

In the wear track, the maximum depth is about 0,1 to 0,15 mm after 1000 cycles.
