**HTR-E**

**High-Temperature Reactor Components and Systems**

**Deliverable D41-b for "Tribology in Helium Environment"**  
**Realization of elementary tests**

**Deliverable D 41-b**

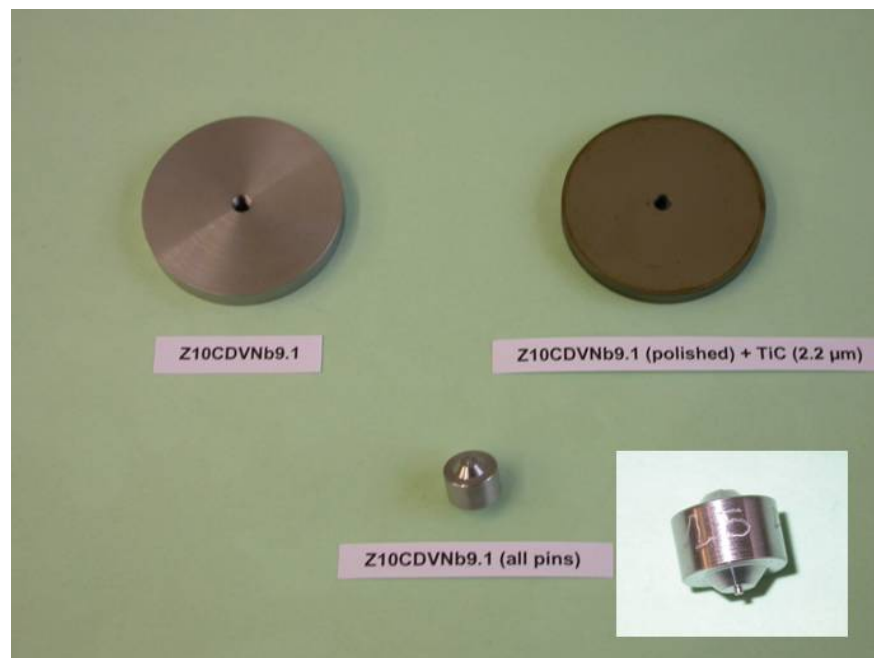
Figure 6: samples based on Z10CDVNB9.1

For this series of tests, the base material is Z10CDVNB9.1 (named 9%Cr 1%Mo), and the contact pressure is 50 MPa. To get this value with a maximal load of 22 N, the contact dimension is limited at  $\varnothing$  0.75 mm (Figure 6).

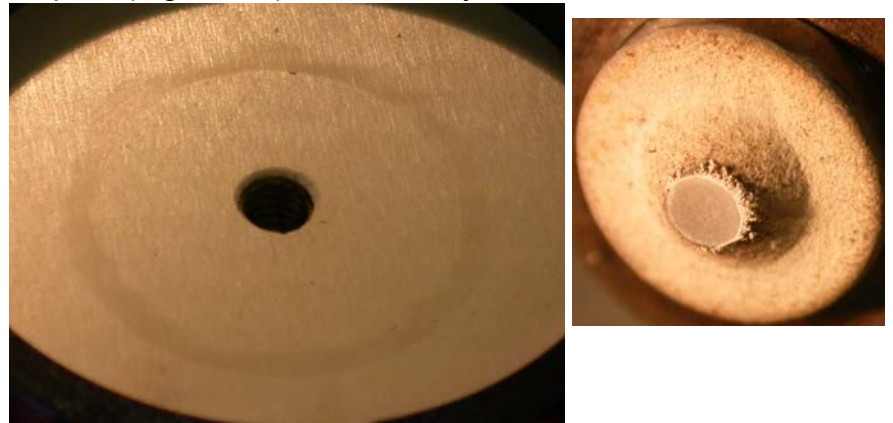
Figure 15: Pictures of samples from test 6

The pictures of samples (Figure 15) show a very low wear with a smaller amount of debris than in test 5. The track on the disk is not regular. The wear volume on the disk is not measurable. That confirms the visual observation.

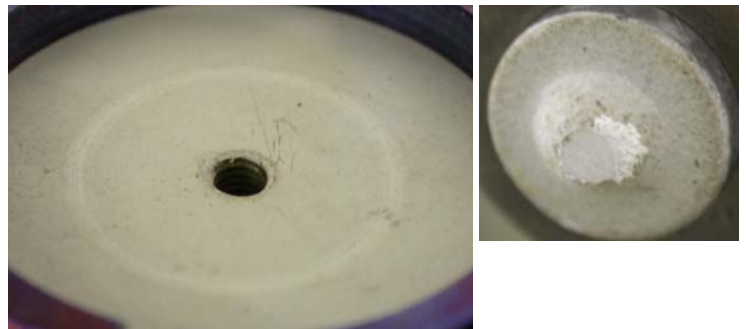
Figure 20: pictures of samples from test 7 before dismounting

The wear is very low but we can observe (Figure 20) a small amount of debris. The wear volume of the disk is not measurable by profilometry (see pages 2 and 3 of appendix1).

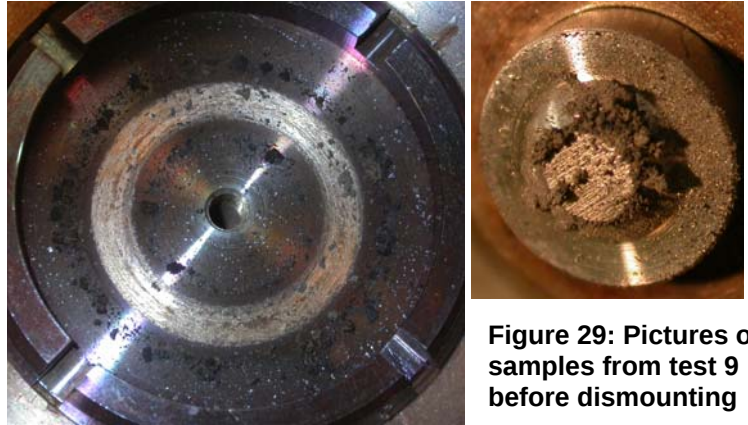
**Figure 29: Pictures of samples from test 9 before dismounting**

The pictures (Figure 29) show a lot of debris on both pieces, agglomerated. The track of pin diameter 0.75 is not visible. That confirms the hypotheses that it has been broken at the beginning of the test.

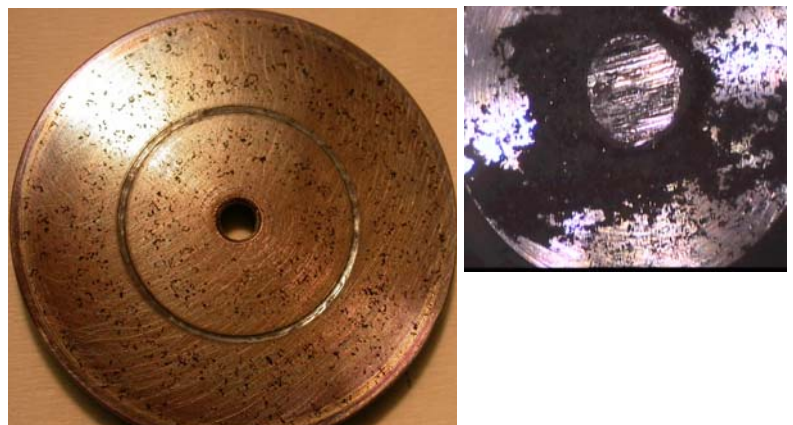
**Figure 30: Pictures of samples before cleaning - Test 10**

The Figure 31 shows the evolution of wear depth and friction coefficient during the test. The debris created is visible on the pictures Figure 30. The wear volume is 2.03 mm<sup>3</sup>, and the maximal depth observed on 4 profiles is 80 µm, for a sliding distance of 210 m.

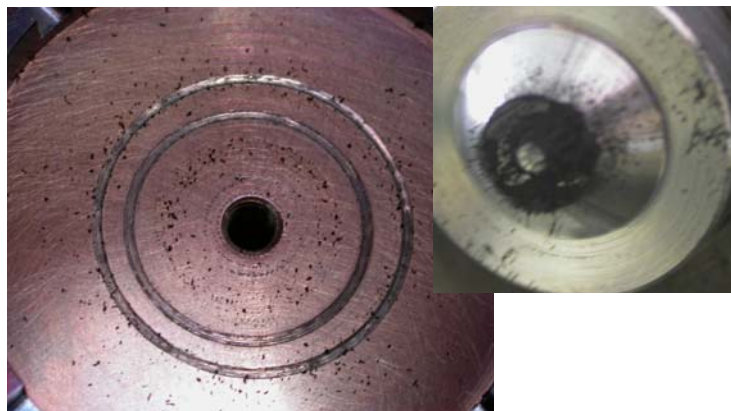
**Figure 32: Pictures of samples before dismounting - Test 11**

The Figure 33 shows the evolution of wear depth and friction coefficient during the test. The wear volume is  $1.01 \text{ mm}^3$  for 201 m, with a maximal depth of  $1 \mu\text{m}$  (always on 4 profiles). The pictures on Figure 32 show a lot of debris on the pin and on each side of the wear track. It's similar to test 10.

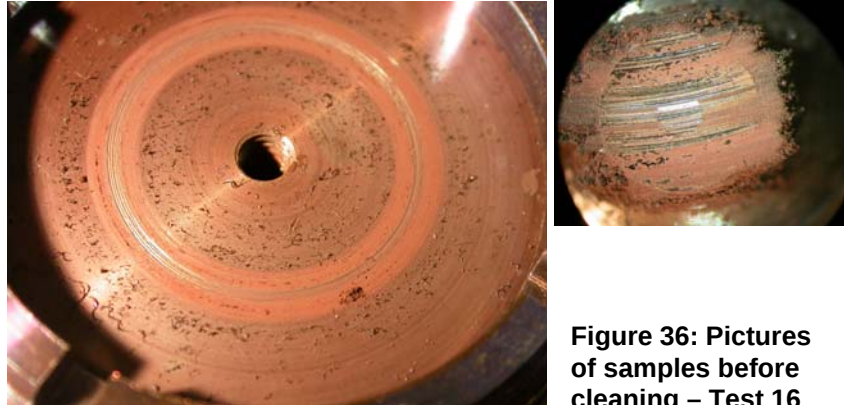
**Figure 36: Pictures of samples before cleaning – Test 16**

to the contact with the pin  $\varnothing$  0.75 mm, and around, the larger track  $\varnothing$  2.25 mm. In the middle of the worn pin, the position of  $\varnothing$  0.75 mm is visible. The wear volume is 0.59 mm<sup>3</sup> and the maximal depth is 40  $\mu$ m.

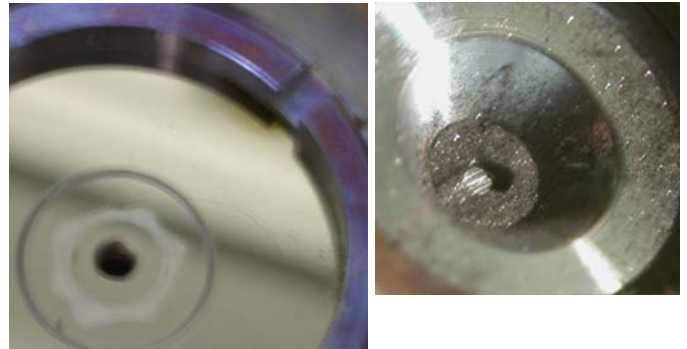
Figure 50: Pictures of samples from test 13

test. On pictures (Figure 50), the debris is on the pin. The wear volume on the disk is  $0.36 \text{ mm}^3$ , and the maximal wear depth is  $25 \text{ }\mu\text{m}$  (measured on 4 profiles), for a covered length of 207 m. The wear on the pin is less important than in previous tests 12 and 14.

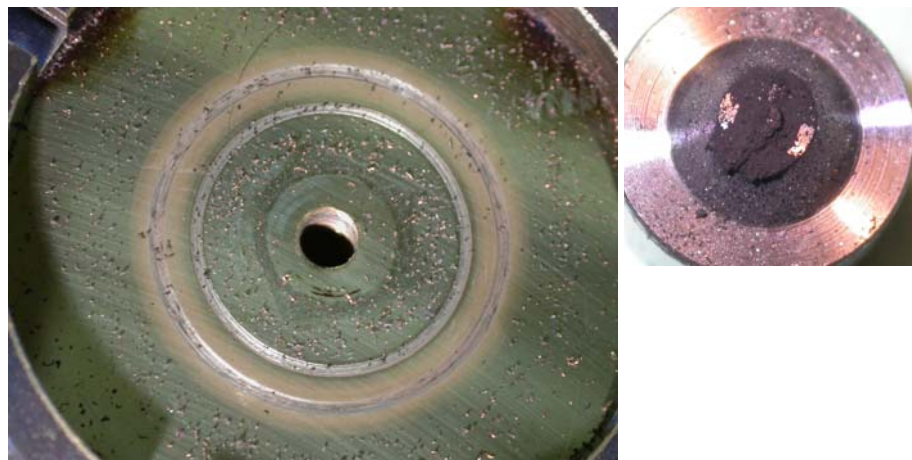
Figure 51: Picture of the samples before cleaning - Test 15

The pictures Figure 51 show debris on the disk, even though there was no debris on the disk in test 13. The pin is covered with debris, coming from the contact.
