### **ARCHER**

## **Test report with determination of creep weld coefficients**

Advanced High-Temperature Reactors for Cogeneration of Heat and Electricity R&amp;D

| Document number | D43.55 |

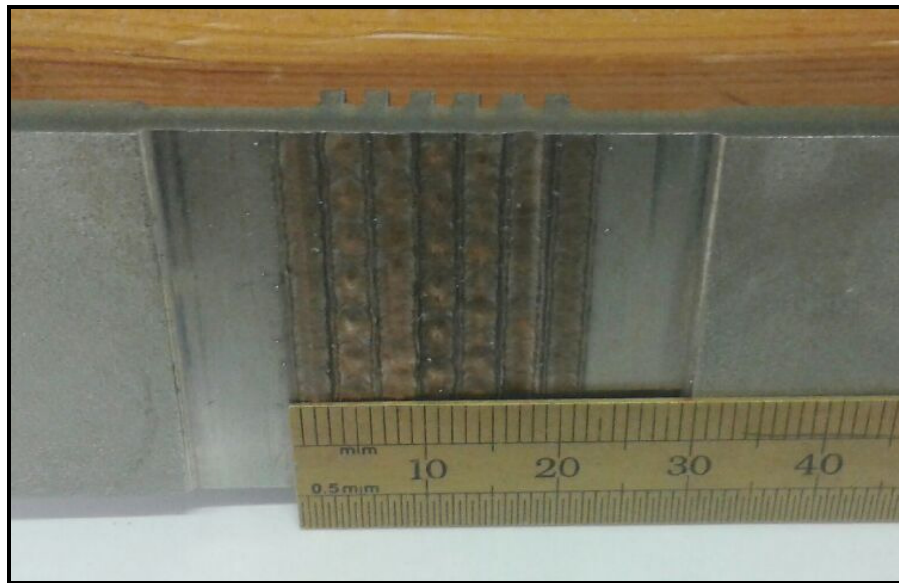
Fig. 18 The length of the weld mid-section gauge length.  
Note in this picture it exceeds 20mm and is ~22mm.

Failures of Tensile and Creep specimens that occur outside the weld / HAZ area possibly show areas of rupture/performance issues where the HAZ area may have extended on one side of the weld (see Hardness results Fig. 3 and 4). The hardness results (Fig. 3 & 4) therefore show an extension of hardness peaks on one side away from the weld area and therefore hard to soft transition areas can occur away from the weld/HAZ area. This evidence is not shown by metallography alone where liquation lines show a very limited HAZ area. These transition areas of differing hardness (Fig. 4) may encourage cracks to form here during elongation under creep stress at elevated temperature. The weld area is approximately 20mm. The area can be larger than this e.g. 22mm (see Fig. 18).
